CALSPAN ON-SITE AIR BAG DEPLOYMENT INVESTIGATION
CALSPAN CASE NO. 92-22
VEHICLE - 1991 MERCURY GRAND MARQUIS LS
LOCATION - [REDACTED], AL
ACCIDENT DATE - [REDACTED], 1992

14. Sponsoring Agency Code	
15. Supplementary Notes On-site investigation of an air bag deployment crash that resulted in multiple fractures of the driver's right forearm.

16. Abstract <p>This investigation focused on an intersection crash that involved a 1991 Mercury Grand Marquis that was equipped with a driver's side air bag Supplemental Restraint System. The vehicle sustained a 10 o'clock direction of force impact and underwent a velocity change of 24 KPH (15 mph). The driver was a 73-year-old female with a height of 149.9cm (59") and weight of 56.3kg (125 lbs.). She was wearing the manual 3-point lap and shoulder belt system.</p> <p>At impact, the driver was initiating a left turn and her right hand was positioned at the 11 o'clock sector of the wheel with her forearm extending over the air bag module. As the SRS deployed, the upper air bag module cover flap and air bag impacted her right forearm resulting in AIS-3 level fractures of the radius and ulna and a 340° laceration of the forearm. In addition to t

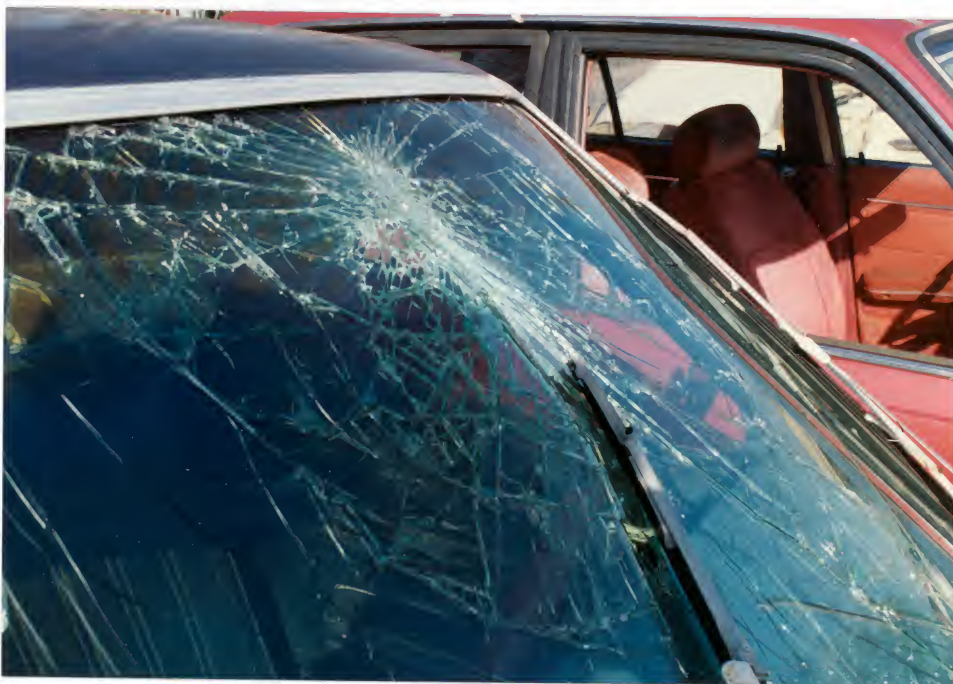
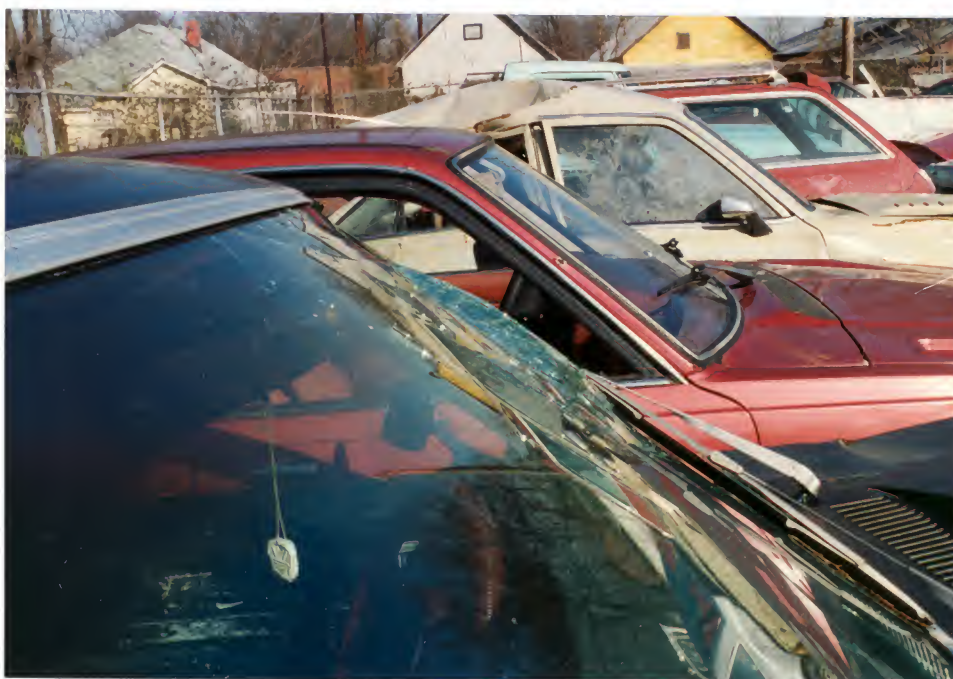
Driver Head Contact To Windshield.

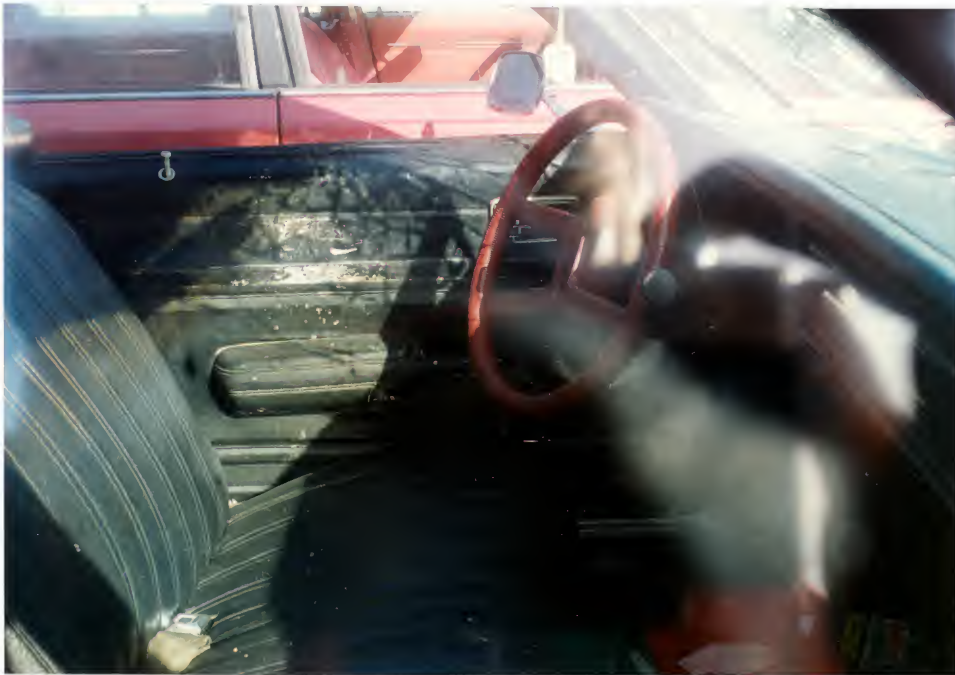
Driver Loading Damage To Steering Wheel Rim.
